Debris/Ice /TPS Assessment and Integrated Photographic Analysis for Shuttle Mission STS-56

May 1993

DEBRIS/ICE/TPS ASSESSMENT
AND
PHOTOGRAPHIC ANALYSIS
OF
SHUTTLE MISSION STS-56

April 8, 1993

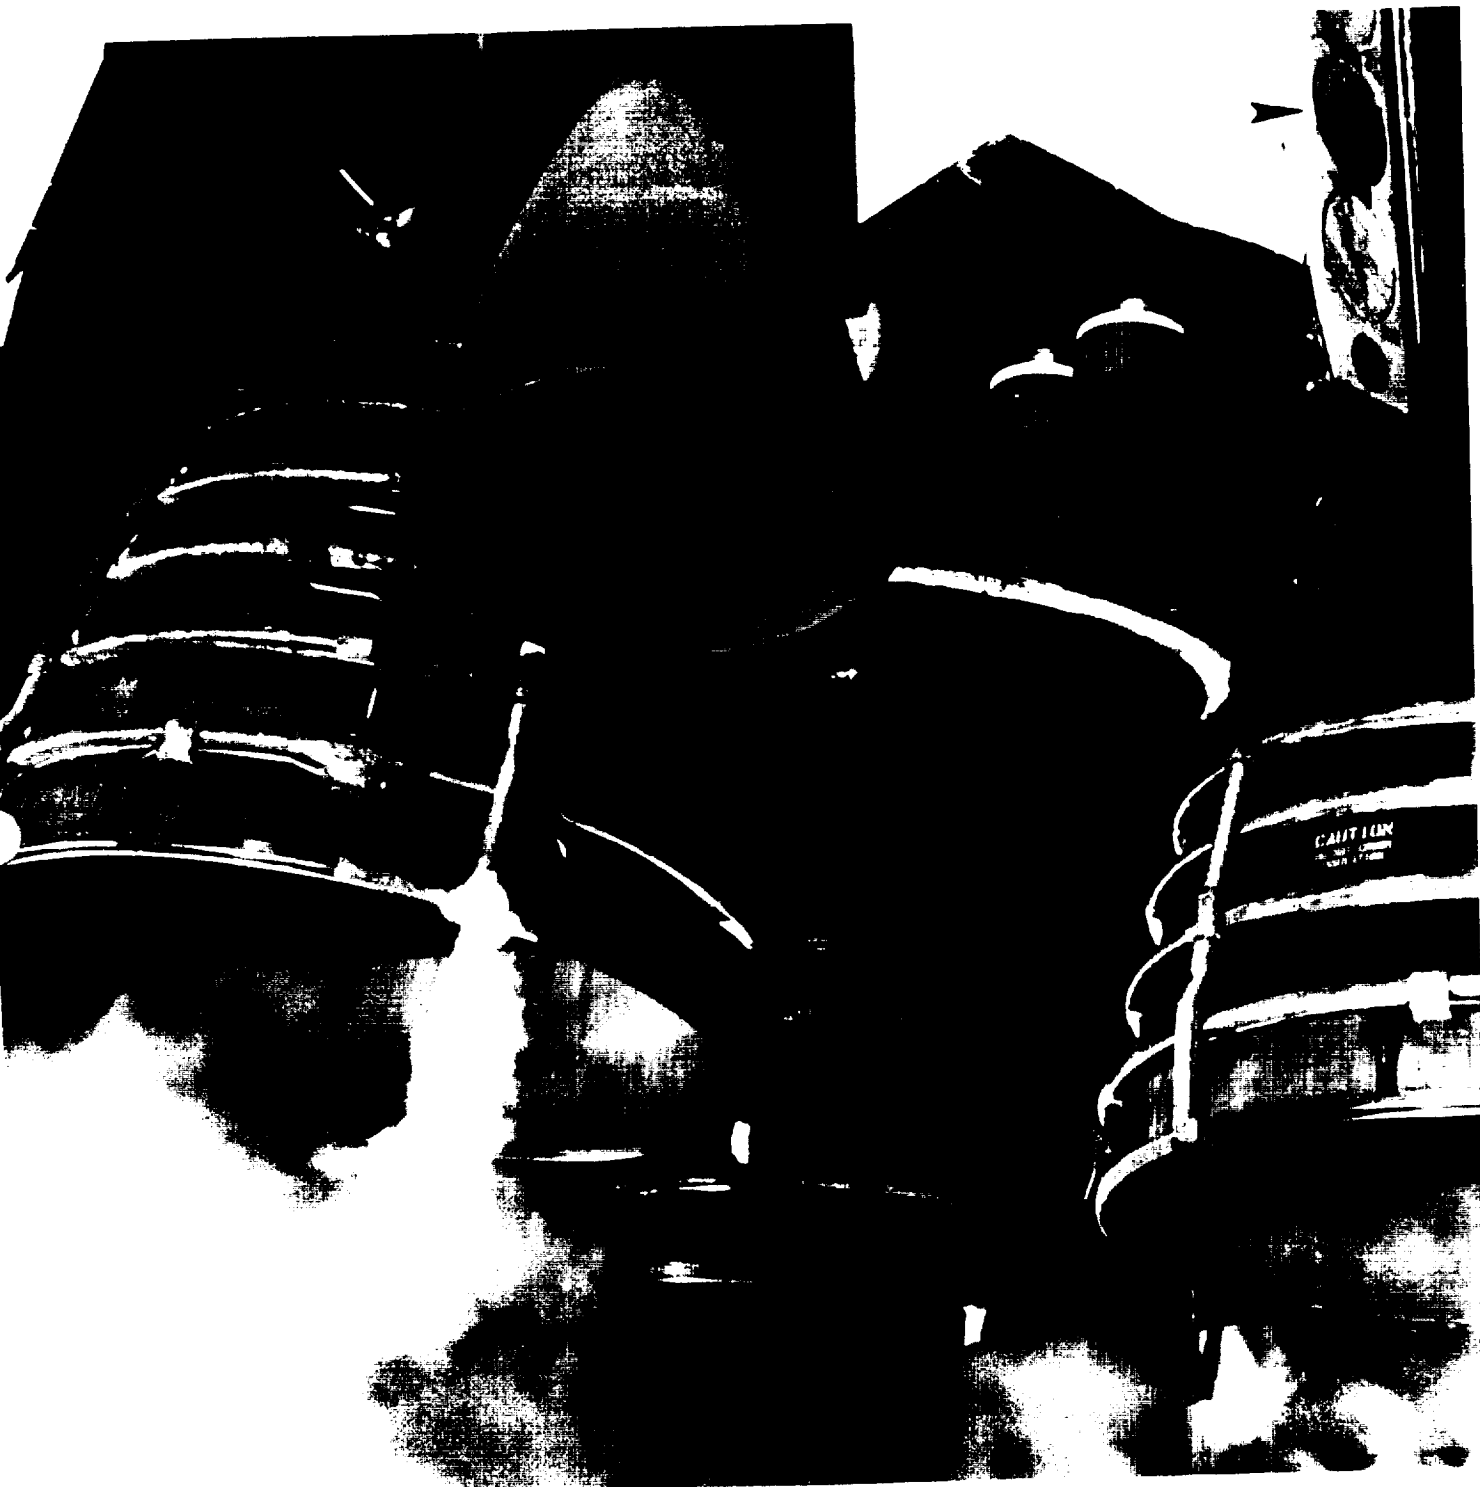
Typical ice/frost accumulations were present at the SSME #1 and #2 heat shield-to-nozzle interfaces. The R3R aft RCS thruster paper cover had been wetted by vapors.

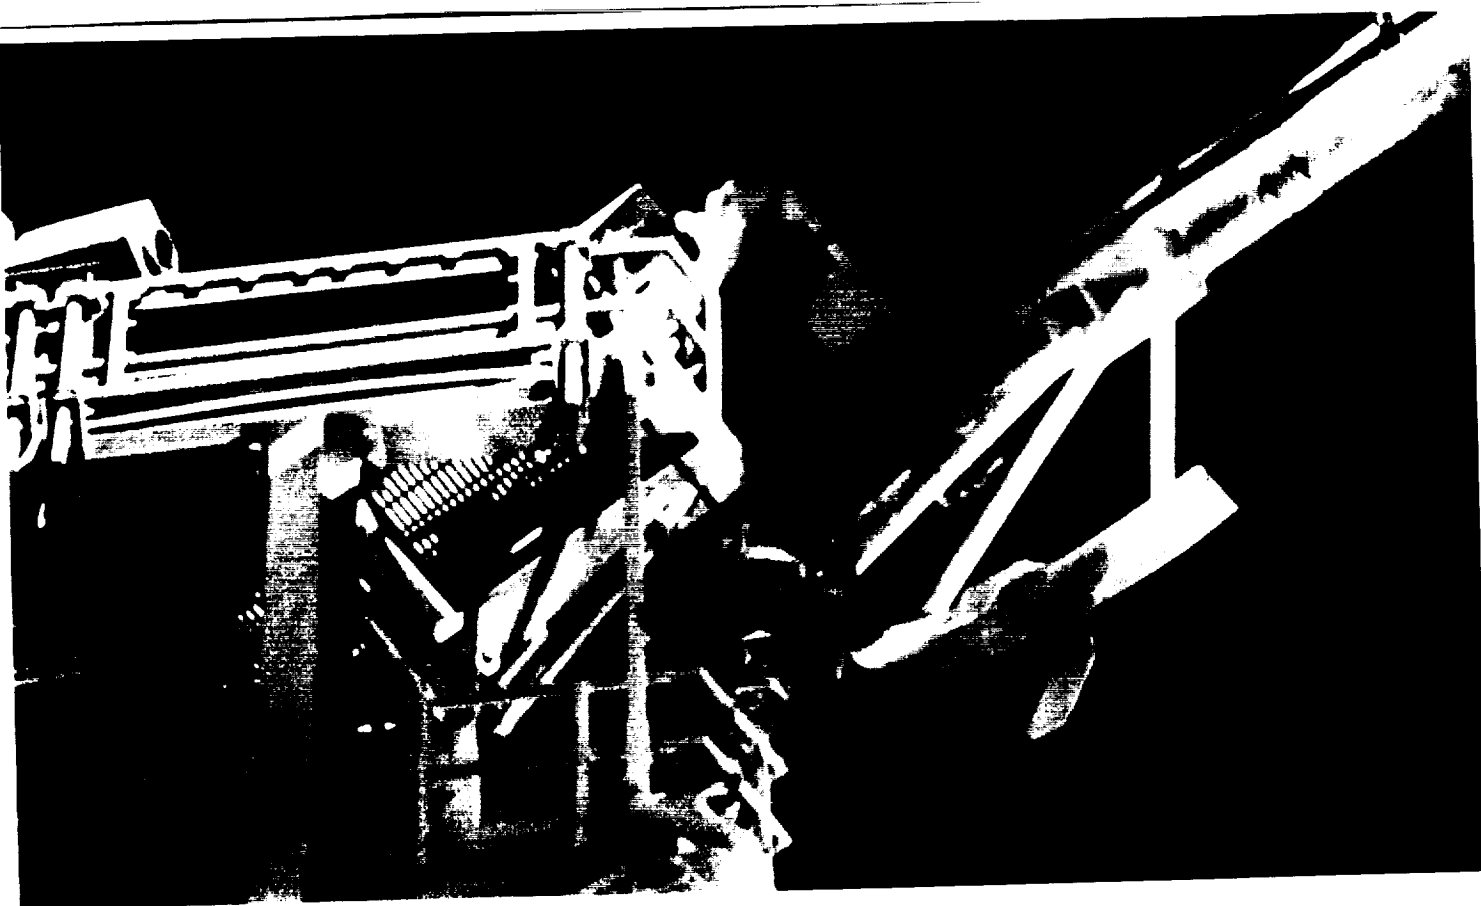
Venting vapors and an ice/frost buildup at the GH2 vent line 90 degree elbow/flex line flange (covered by an ice shroud) indicated the presence of a hydrogen leak, which was confirmed by a hydrogen detection meter. Since the leaking hydrogen was not driven by a pressurized GH2 vent line, and the line itself would be purged at T-90 seconds, the condition was not a constraint to launch. The ice buildup measured 10" x 4" x 3/8" thick and may have been a debris threat to Orbiter tiles. However, the easterly winds and the structurally enclosed area of the ice buildup would prevent large pieces of ice from falling toward the vehicle. Post launch disassembly of the elbow/flex line flange revealed the old Fluorogreen gasket, which was cracked, had not been removed prior to installation of the new Fluorogold gasket. In addition, the flange bolts had not been re-torqued after the last cryogenic loading cycle.

A hydrogen leak at the GH2 vent line elbow/flex line flange was detected by the on-pad Ice Team. The visual signs of venting vapors and ice/frost buildup showed the exit point from the ice shroud. The line was depressurized and purged prior to launch.

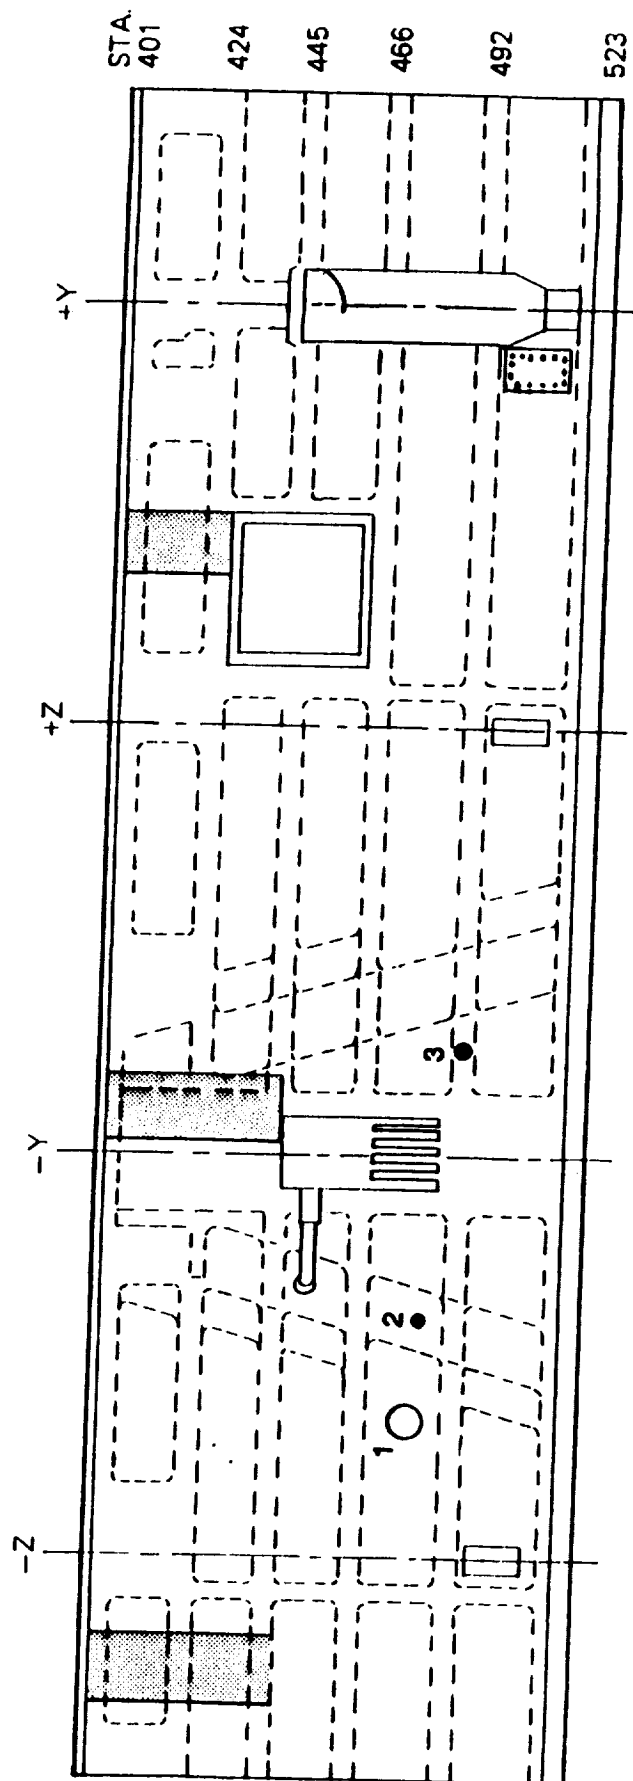
FIGURE 8. RIGHT SRB FWD SKIRT

TPS MISSING
1) 5" x 3"
(MAY BE
HANDLING
DAMAGE)

DEBONDS
2) 1.5" DIA
3) 3.0" DIA

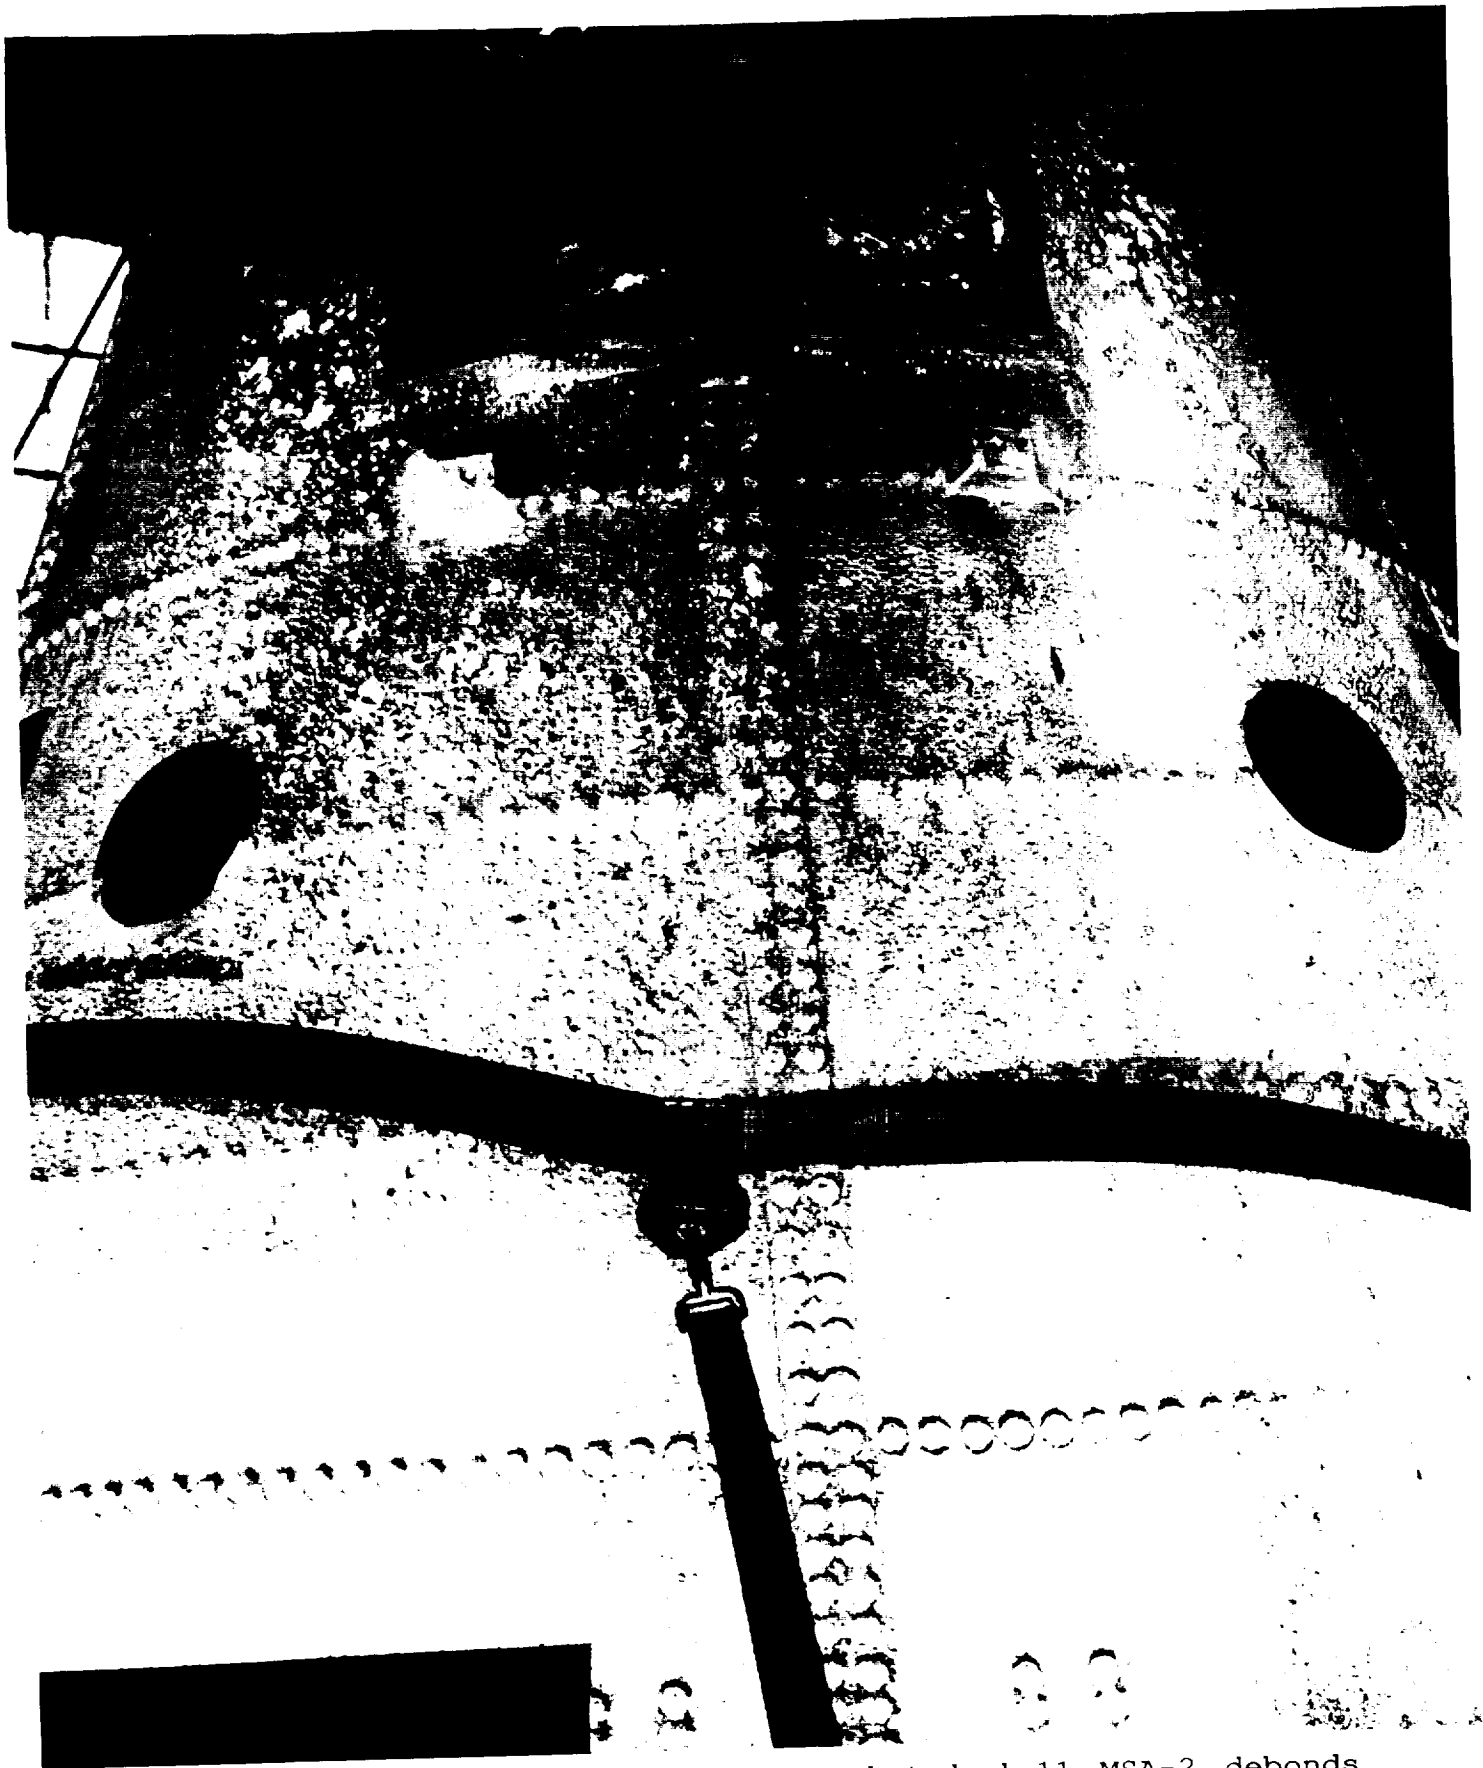
The RH frustum was missing no TPS, but had 11 MSA-2 debonds over fasteners. Significant blistering of the Hypalon paint top layer had occurred in an area around and aft of the BSM's.

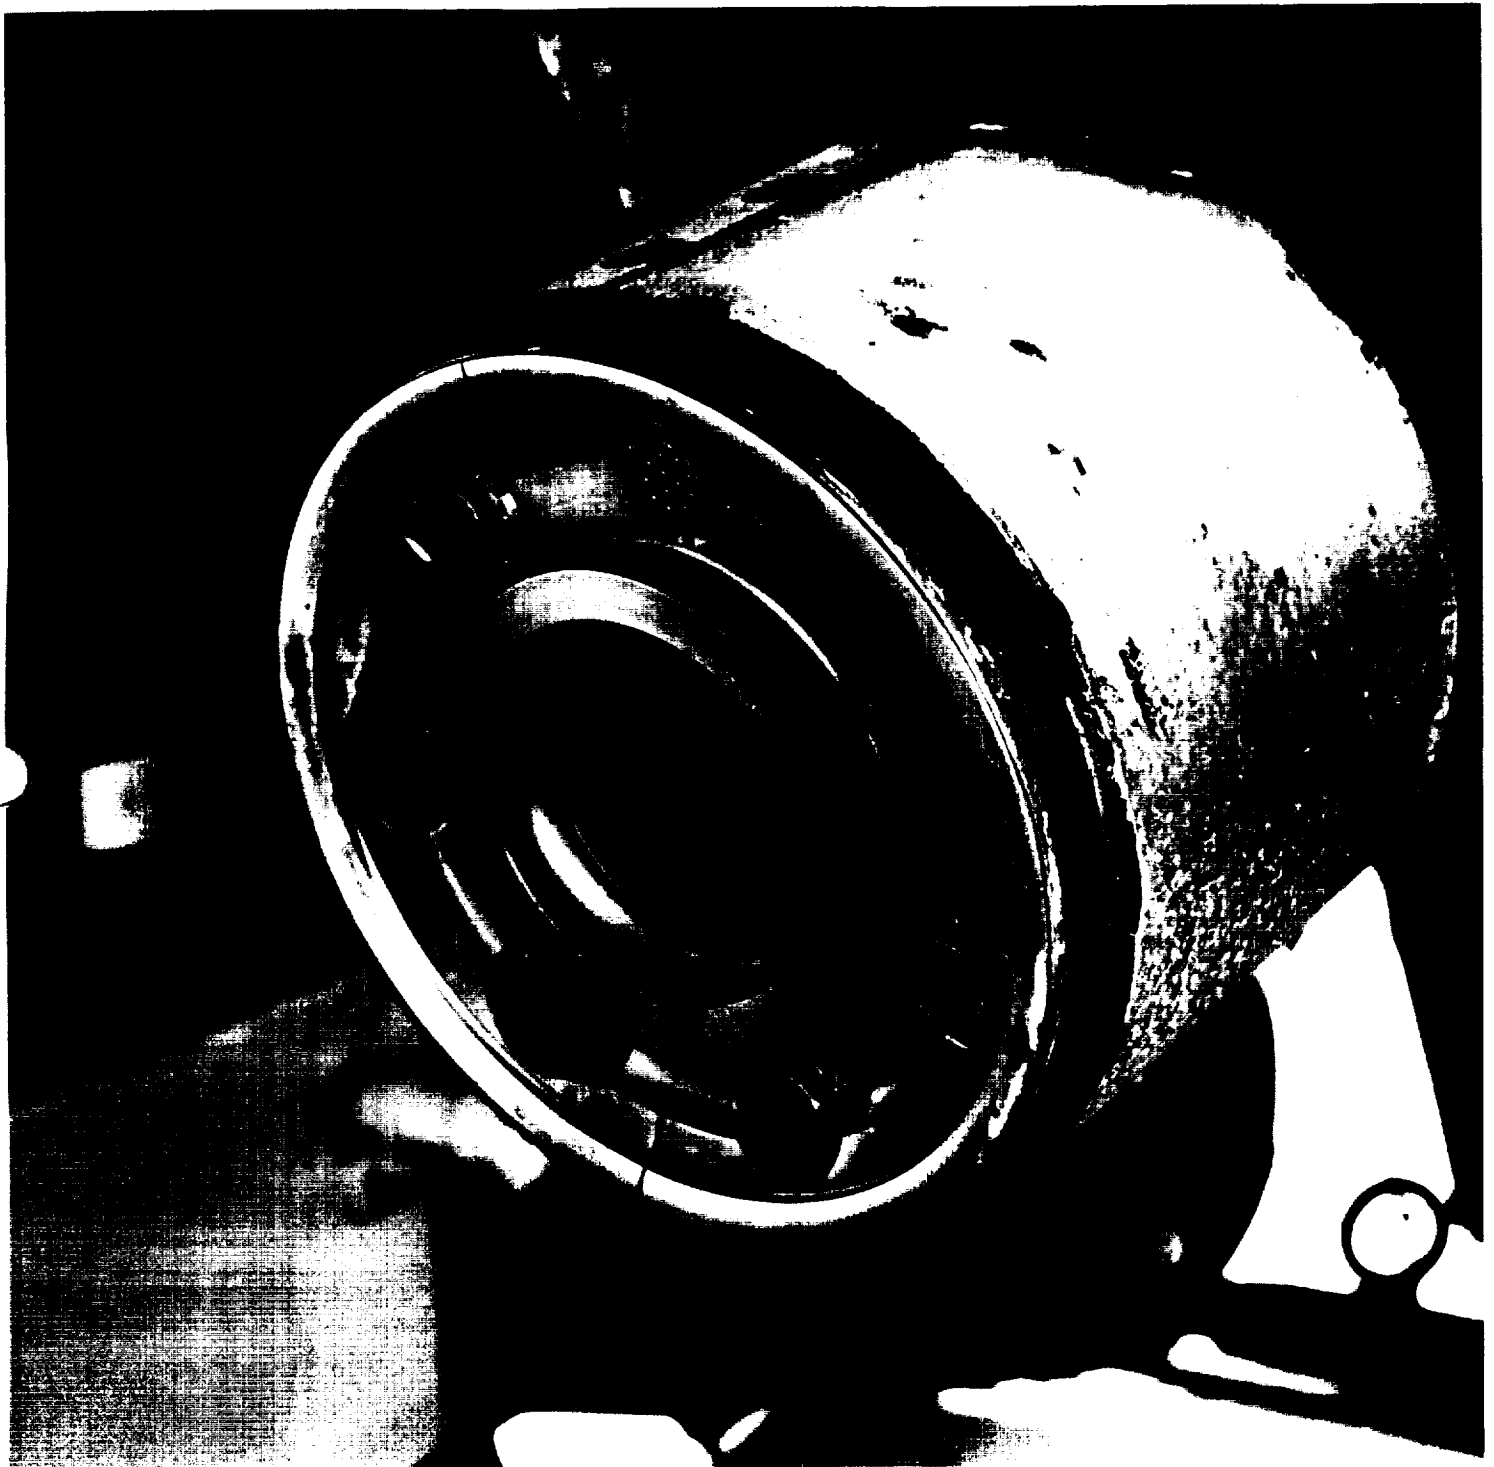
K5NA, 5"x1" in size, was missing from the upper strut fairing

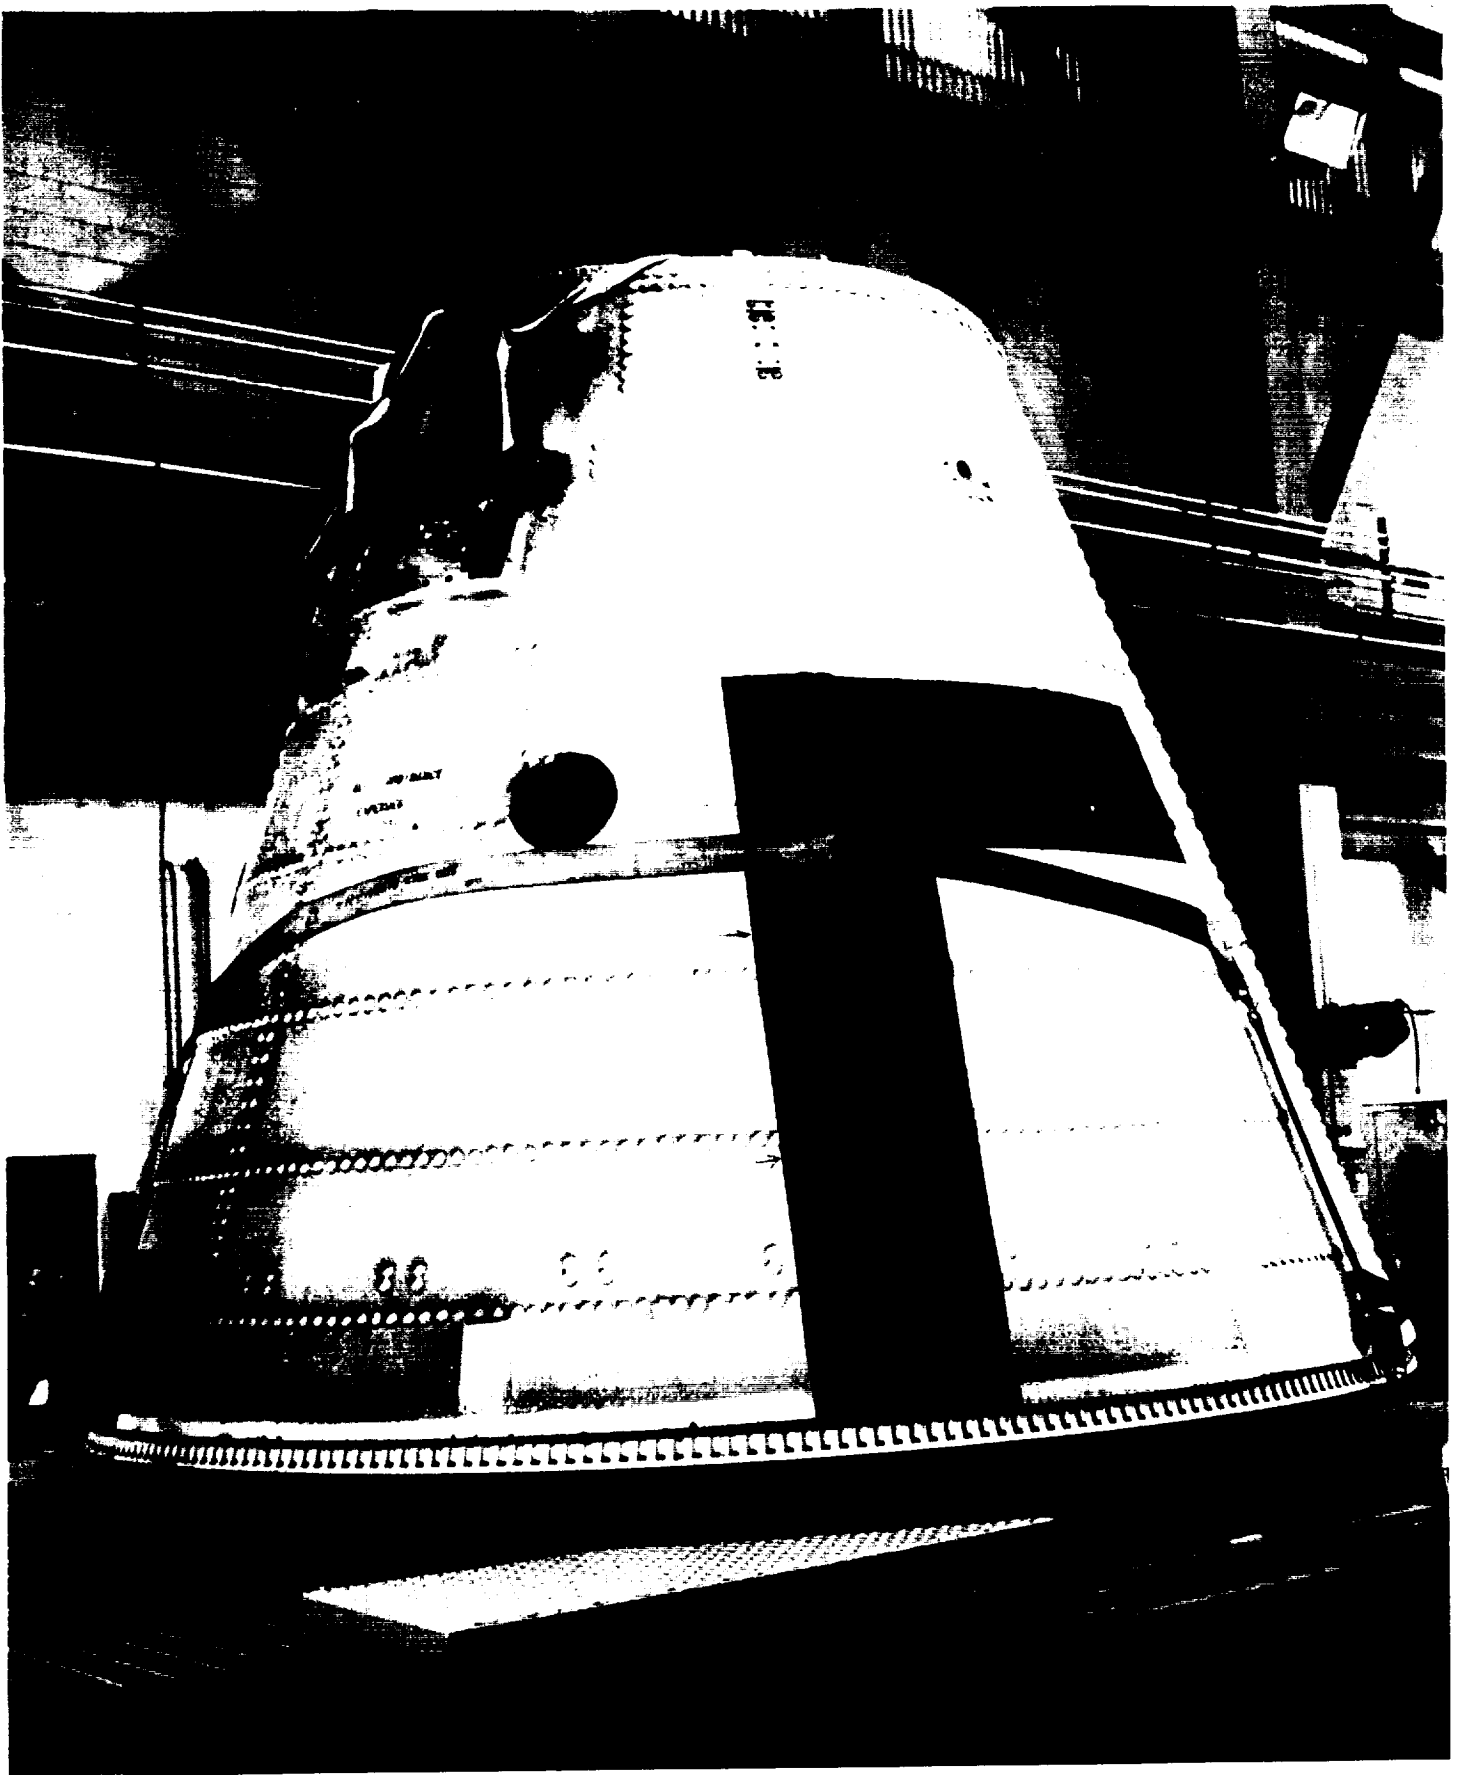
The LH frustum was missing no TPS, but had a total of 20 MSA-2 debonds. The BSM aero heat shield covers were locked in the fully opened position.

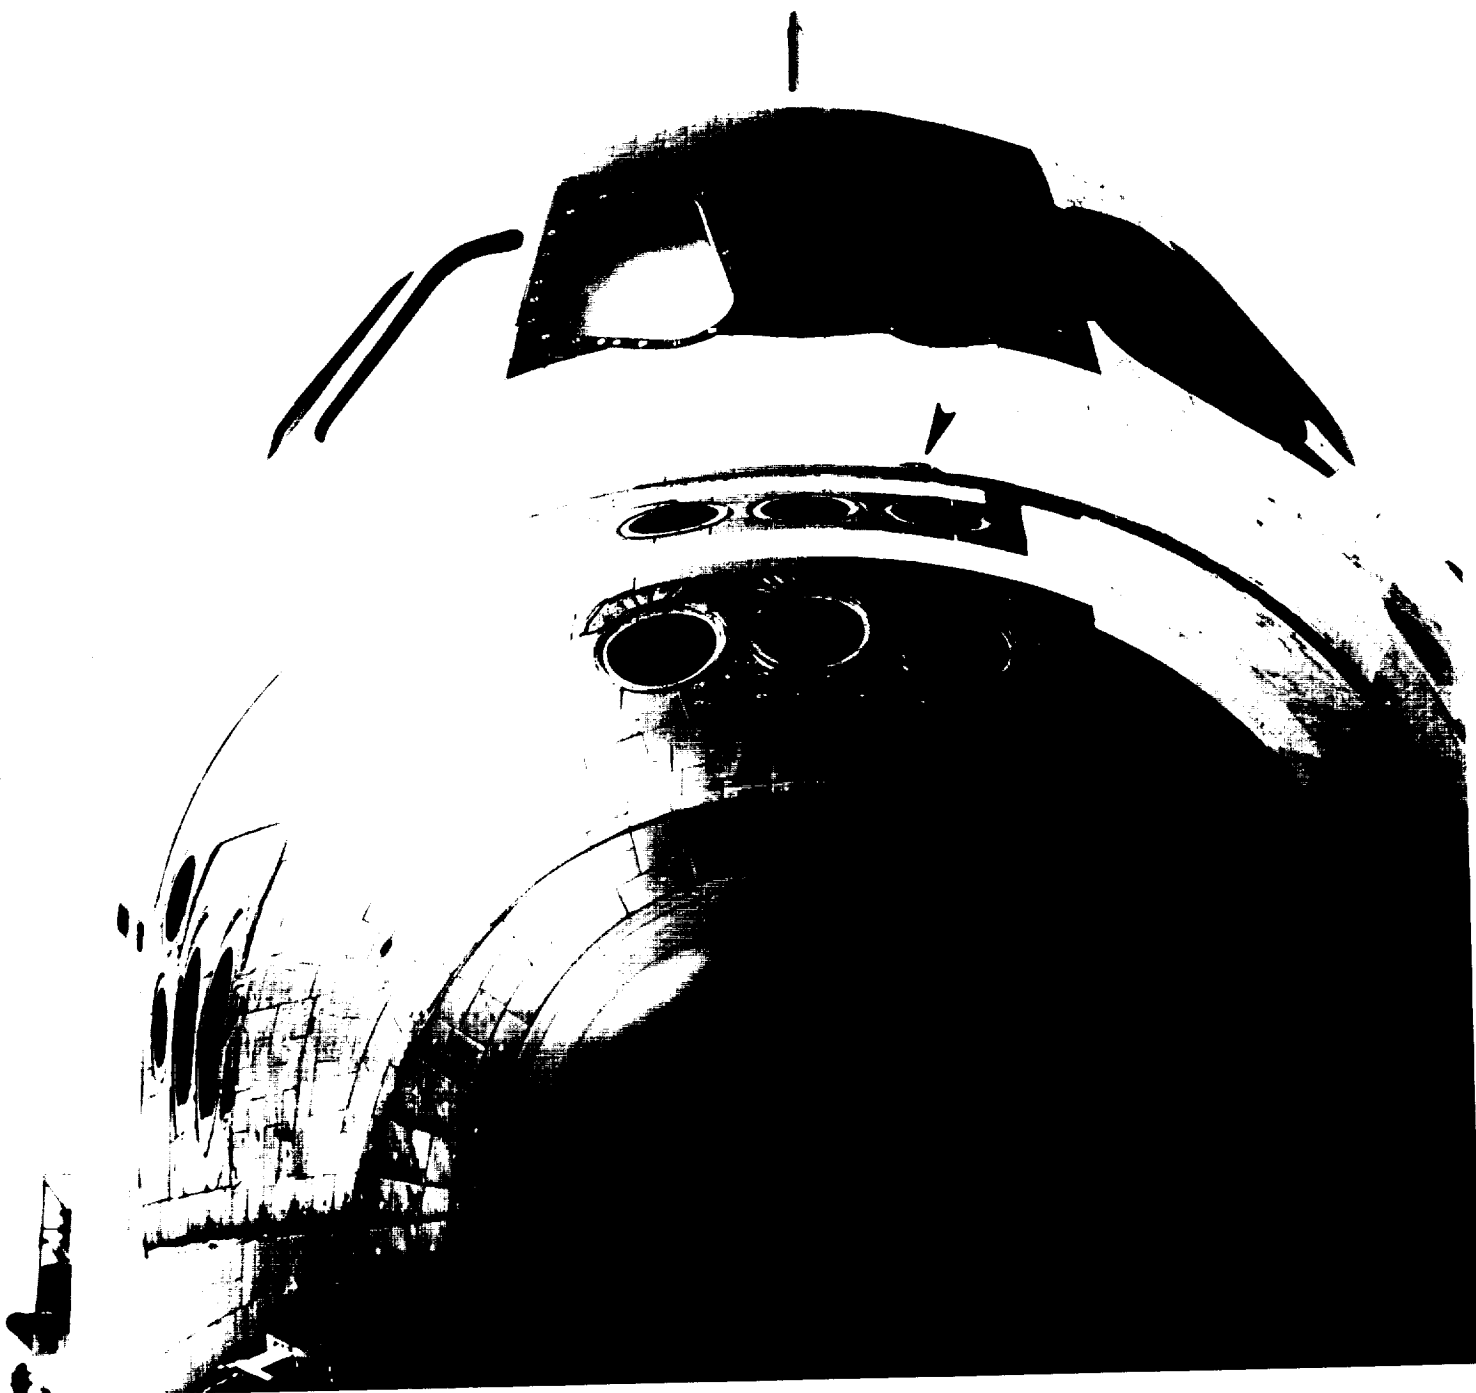
Overall view of Orbiter nose. Note moderate hazing of forward facing windows and small damage sites on window perimeter tiles. Part of a AFRSI panel is loose aft of FRCS thruster F1U.

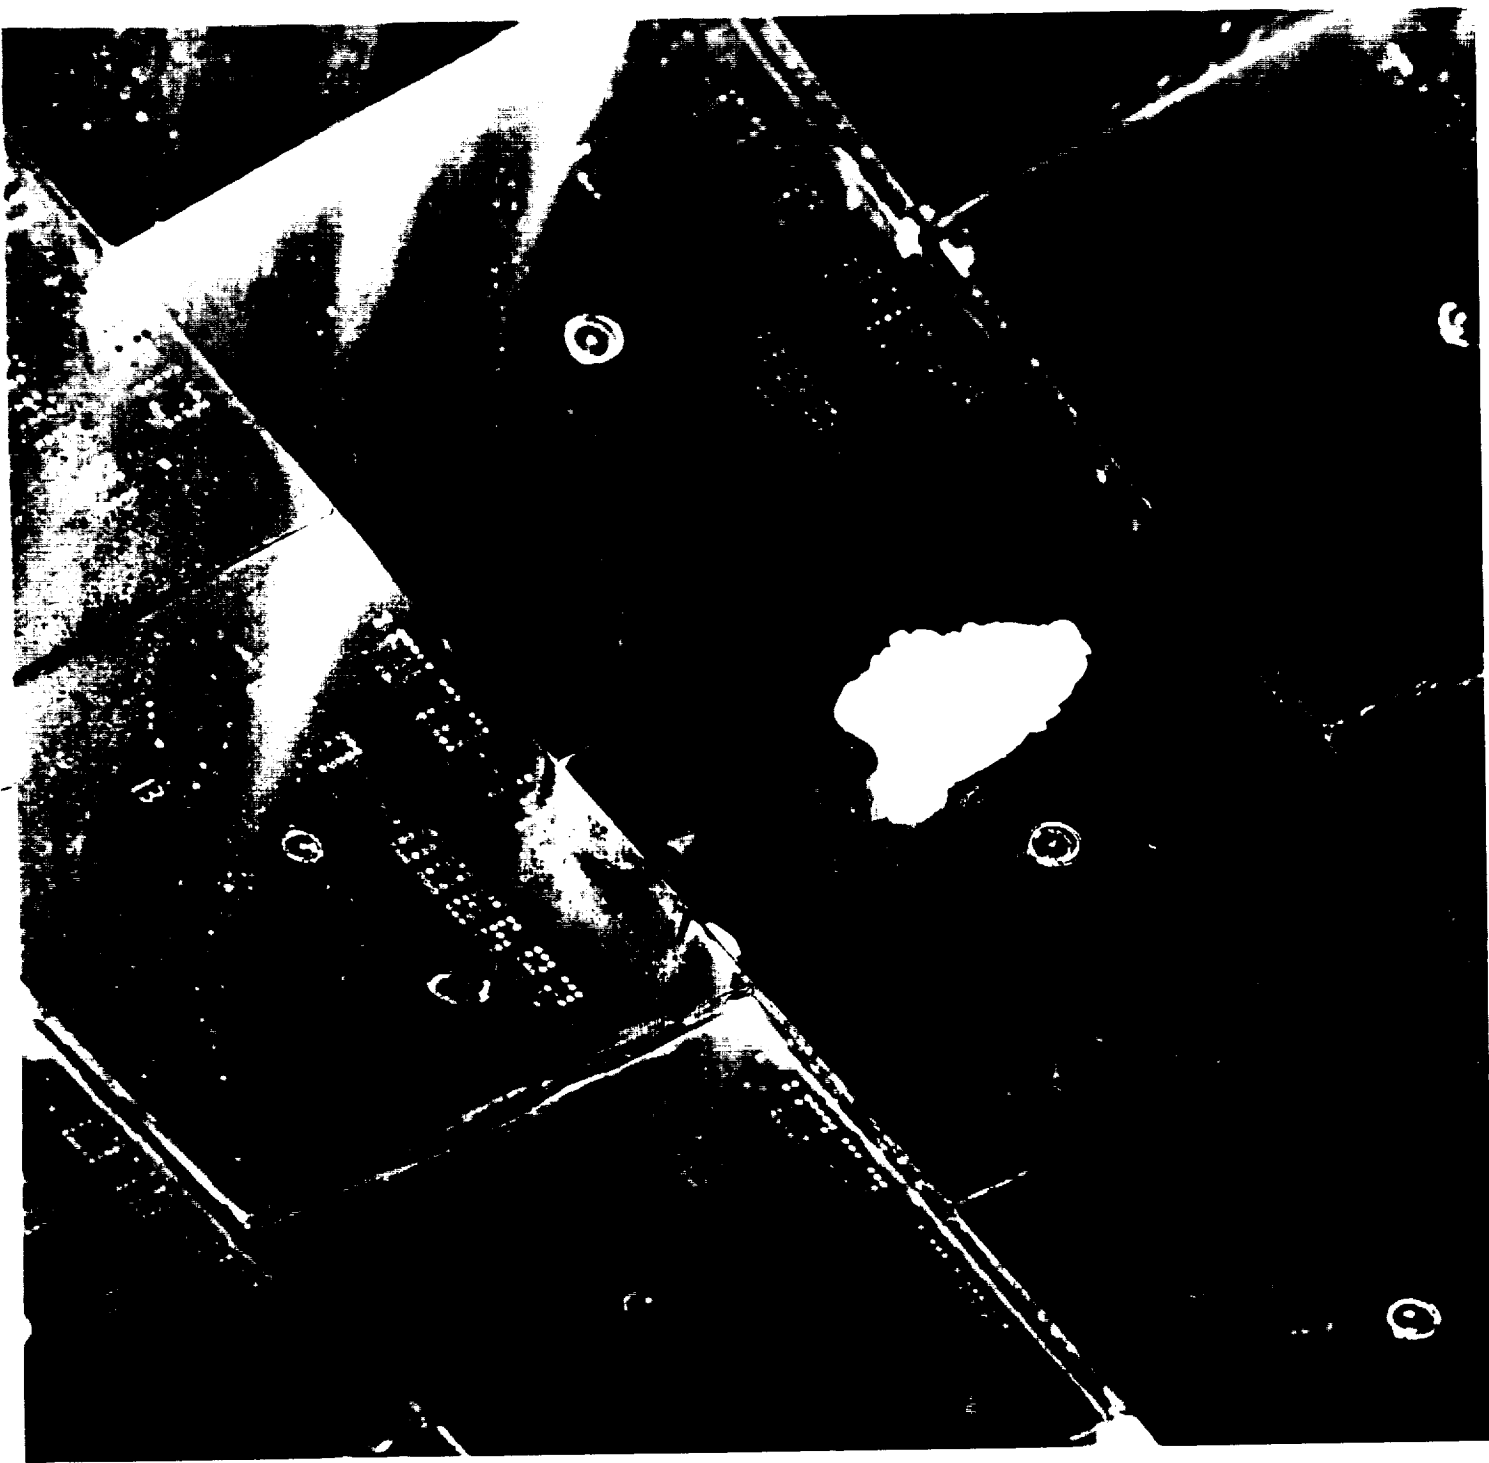
The Orbiter lower surface tiles sustained a total of 94 hits,
of which 18 had a major dimension of 1-inch or greater.

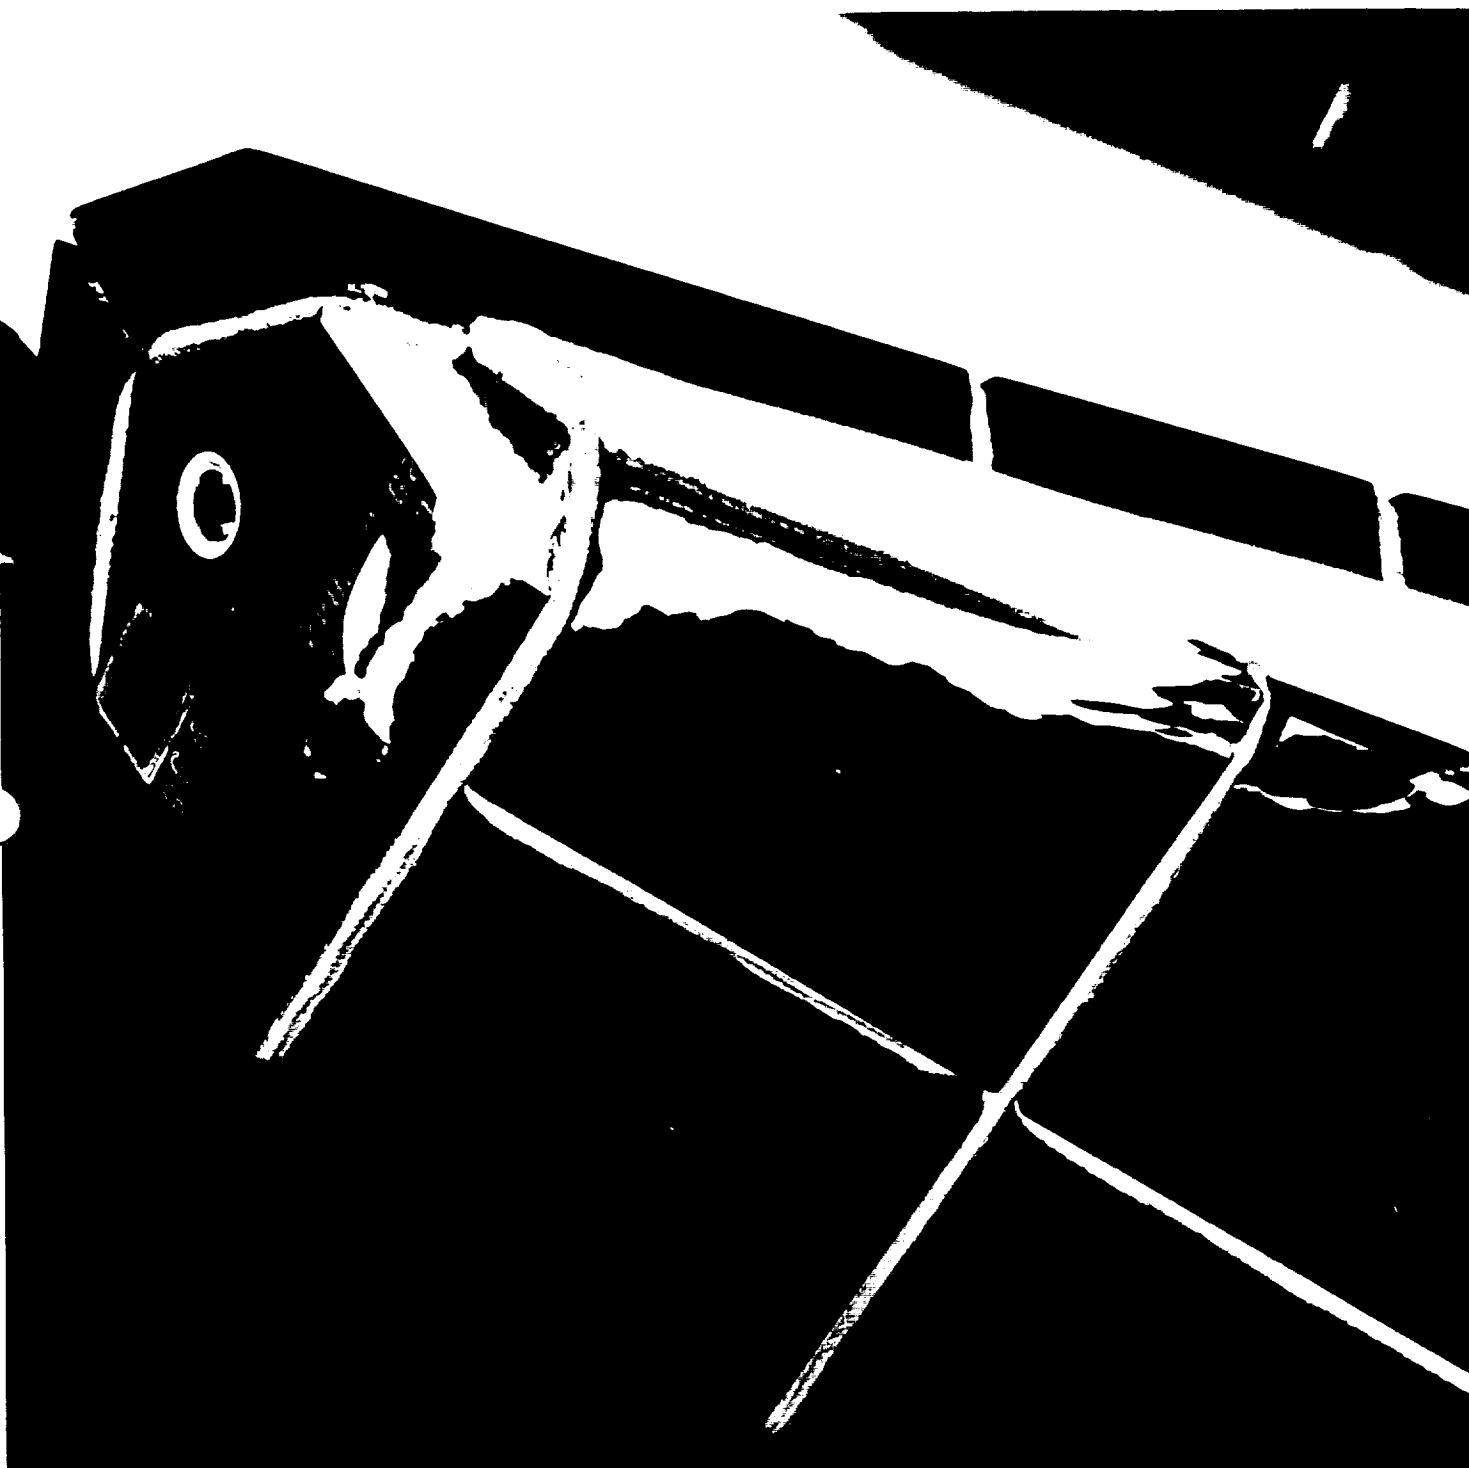
Eight tile fragments found on the runway originated from the vertical stabilizer "stinger" and had been dislodged by contact with the drag chute riser lines during deployment.
